Power Trim Leak Down - 40 Thru 115

This is a revision of Outboard Service Bulletin 93-22. Destroy Bulletin 93-22 and insert Bulletin 93-22A. Changes are underlined.

Mariner And Mercury

1993 and 1994 40 Thru 115

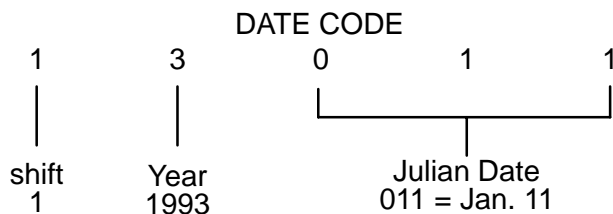
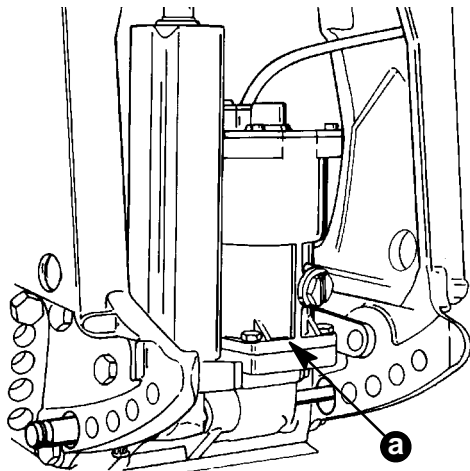
Figure 1. Date Code Location.

a - Date Code

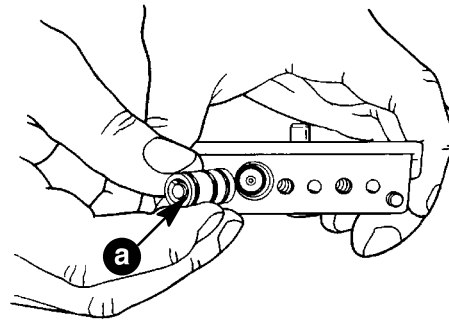
Figure 2. Side View of Manifold.

a - Sleeve with Spool Inside.

To correct, remove the tilt cylinder from the manifold and replace the pilot valve assembly as outlined in the outboard service manual. It is NOT necessary to replace the complete power trim to correct the problem.

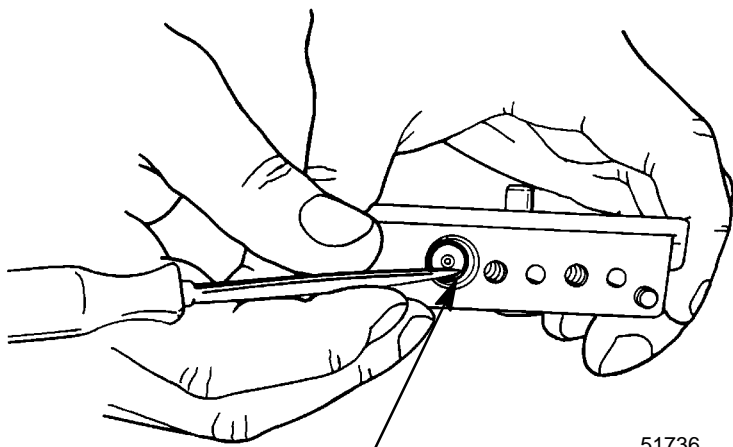
The spool is stuck when the pin end of the spool is protruding out past the end of the sleeve.

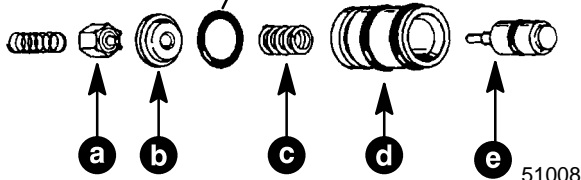
Figure 5. Pilot Valve and Seat Removal.

- a - Pilot Valve.
- b - Valve seat.
- c - Return Spring.
- d - Sleeve.
- e - Spool.

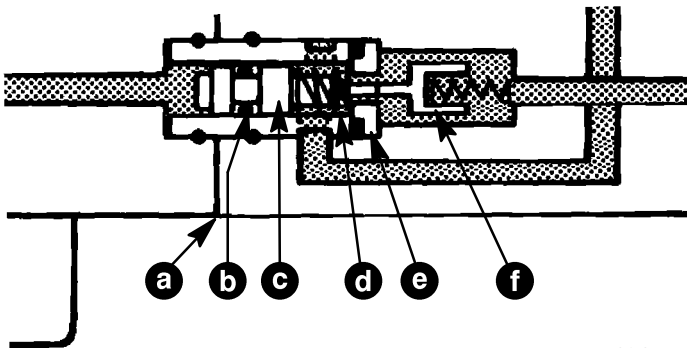
Figure 6. Pilot Valve Held Open.

The 1993 and 1994 models listed with power trim date codes 13011 thru 23288 ONLY may experience a very slow up trim rate (one minute or more) with the outboard drifting back down as soon as the UP trim button is released. This failure usually occurs when the unit is new or after three or four weeks of non use. The cause may be a stuck spool inside the sleeve due to an oversize or a hard O-ring on the spool.

A leak path is created between the UP side of the cylinder and the reservoir, when the spool sticks holding the pilot valve open.

- a - Cylinder/Manifold Mating Surface.
- b - O-Ring in Question.
- c - Spool.
- d - Return Spring.
- e - Valve Seat.
- f - Pilot Valve Held Open (away from valve seat).

Power trim units with date code 23289 and higher have improved O-rings and improved surface finish on the inside of the sleeve to correct the problem.
