service bulletin

No. 94-10

Power Trim Shaft Not Engaging Sender - 75 thru 125

Mariner and Mercury

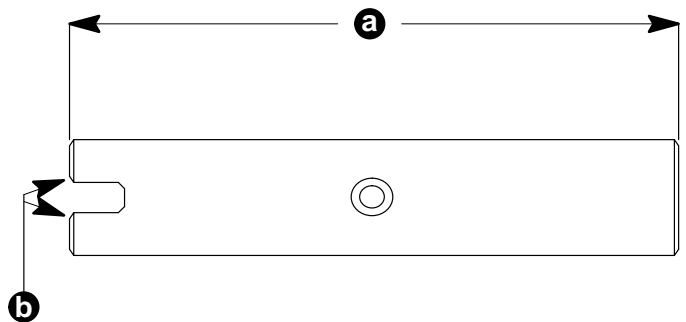
Figure 1. 99625--1 Pivot Shaft.

The new pivot shaft p/n 99625--1 is installed on late 1994 75 thru 125 models beginning after the serial numbers listed and supersedes the previous pivot shaft p/n 99625. The new shaft is slightly longer and does not have the chamfer at the outer end of the slot.

a - Slightly Longer.

b - Chamfer Removed.

If the pivot shaft does not engage the sender, install the new slotted pivot shaft p/n 99625--1.

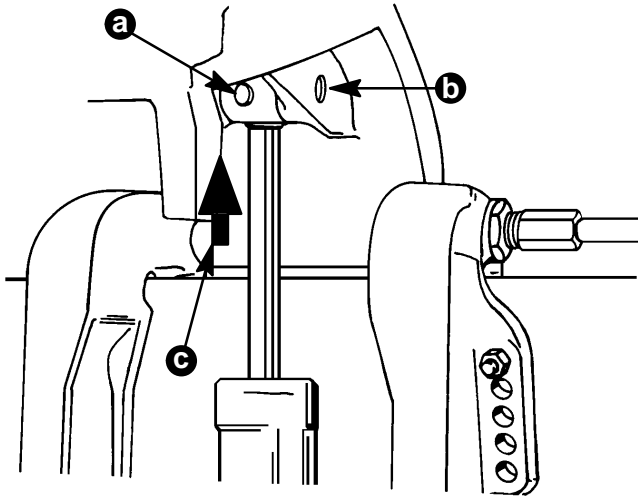
Figure 2. Shim Washer Location.

- a - Cross Pin.
- b - Upper Pivot Shaft.
- c - Install Washer(s).

In an emergency, shim the power trim rod eye over toward the starboard side using the washers listed.

Remove the cross pin and the upper pivot shaft. Install 0.125 inch (3 mm) washer(s) listed between the port side of the power trim rod eye and the swivel bracket. Reinstall the upper pivot shaft and the cross pin.
