# service bulletin

No. 94-13

## Power Trim Partial Leak Down at Maximum Trim – 75 thru 125

### Mariner and Mercury

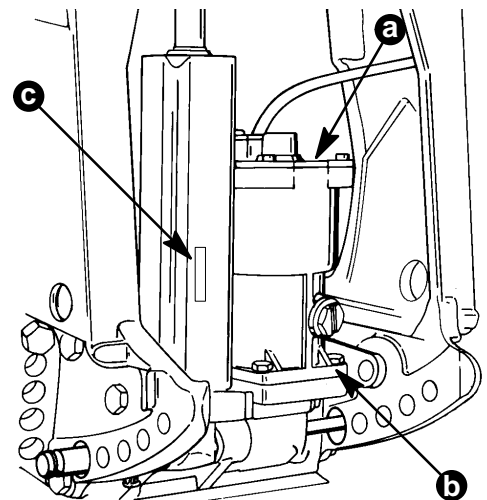
**Figure 1. Date Code Locations:**

- a - Label on top cover of motor.
- b - Motor reservoir flange.
- c - Embossed into the caution decal on trim/tilt cylinder (this might be difficult to read).

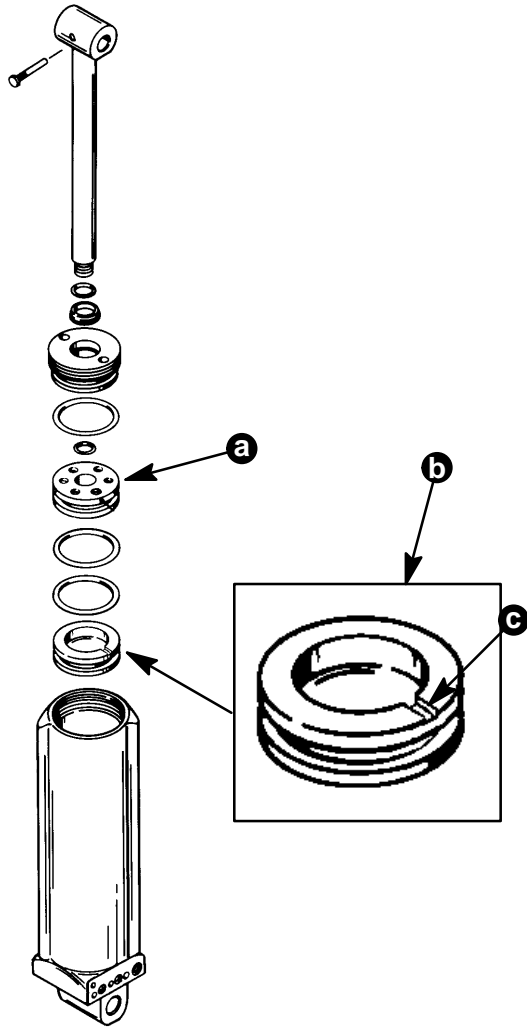
**Figure 2. Trim/Tilt Cylinder Assembly.**

Single ram power trim units are designed to trim the outboard to a maximum of 20 degrees. Some units, when trimmed to the maximum 20 degree limit, will leak down approximately 5 degrees and then hold. The leak down will ONLY occur while the boat is under power. The cause for the 5 degree leak down is the lack of a fluid passage between the shock piston and the memory piston. For other leak down symptoms, refer to service bulletin 93-22A.

a - Shock Piston.

b - Memory Piston.

c - .020 – .040 Inch (.5 – 1 mm) Groove.

Disassemble the power trim/tilt ram assembly (refer to the service manual) and remove the memory piston. Cut a small groove .020 – .040 inch (.5 – 1 mm) deep across the top face the memory piston (figure 2). The groove will allow oil passage when the shock piston and memory piston are in contact. The groove can be easily created with a hacksaw or triangular file. Remove all burrs and filings from the memory piston. Reassemble the trim/tilt ram assembly using new O-rings and seals.
