## GEARCASE FAILURES - 75 thru 125

This is a revision of Outboard Service Bulletin 96-17. Destroy existing Bulletin 96-17 and insert revised Bulletin 96-17.

1995, 1996 and 1997 Mercury / Mariner 75 thru 125 HP Models, serial number  
USA 0G077367 thru 0G589999  
BELGIUM 9836633 thru 9973099

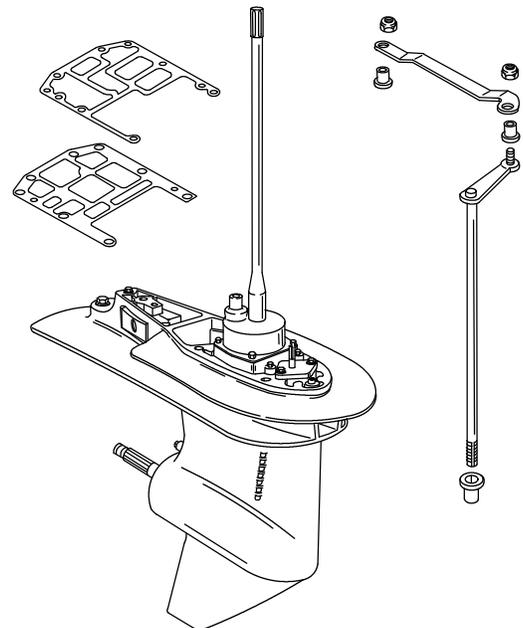
Replacement gear housing assembly components

Installation of a new 6-jaw clutch style gear housing assembly on non-tiller handle models will require the installation of a new upper shift shaft and shift link arm which involves powerhead removal. The new upper shift shaft, new link arm, and installation instructions are shipped with the gear housing assembly. The installation instructions will show by model which new shift part(s), if any, requires installation.

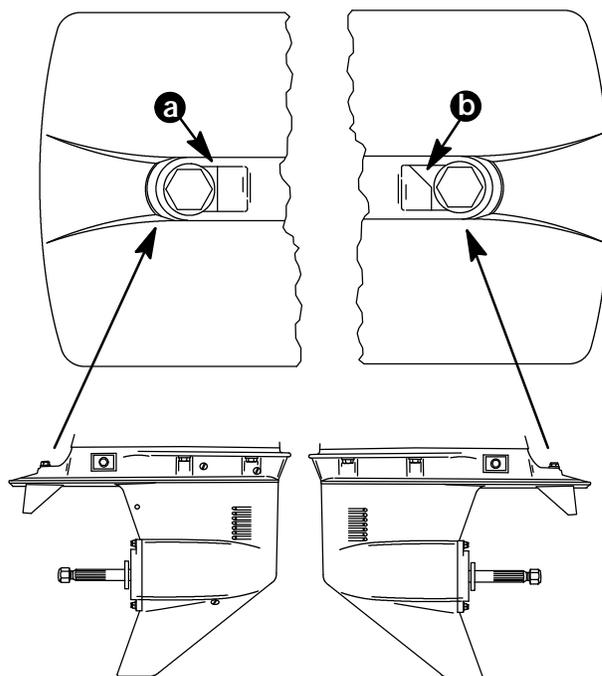
Identify gear case design to ensure correct components are being installed. Design I - "3 Jaw Reverse Clutch" (a) gear case identified with straight machined edge for trim tab screw mounting surface. Design II - "6 Jaw Reverse Clutch" (b) gear case identified with angled machined edge for trim tab screw mounting surface.

1987 - 1997 "3 Jaw Reverse Clutch"      1998 and Newer "6 Jaw Reverse Clutch"

a - Design I - "3 Jaw Reverse Clutch" Gear Case Identifier  
b - Design II - "6 Jaw Reverse Clutch" Gear Case Identifier

After the "6-Jaw Reverse Clutch" gear housing and updated Shift Shaft have been installed replacement parts **MUST** be ordered from the "6-Jaw" section of a 1998 model year and newer parts list. "3-Jaw" and "6-Jaw" reverse clutch parts are **NOT** interchangeable.
