ADVISORY  
 BULLETIN

No. 99-9

## Gearcase Sleeve 41121 - 9.9/15 (4S) & 20/25 (2S)

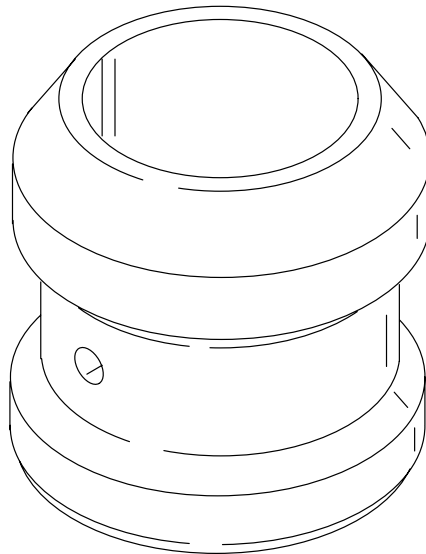
**P/N 41121 Sleeve**

A replacement sleeve p/n 41121 for the gear housing is now available for the models listed. The sleeve is located in the gear housing below the water pump and retains the upper drive-shaft needle bearing and oil seals. Replacement may be required if it becomes corroded or damaged. Removal is difficult without proper tools. It is important to follow the procedures outlined in this advisory. Installation of the new sleeve requires the application of Loctite 271. Sufficient time for a complete cure of the Loctite is also essential.
