ADVISORY
 BULLETIN

No. 2001-06

Official Notification Federal Boat Safety Act Flywheel Nut Retorque - 115 EFI Four Stroke

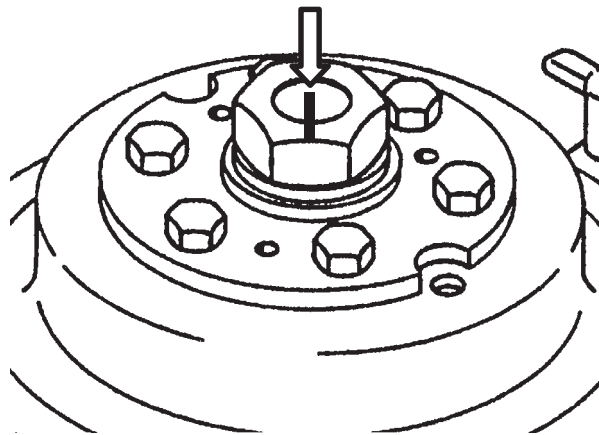
Outboards produced previous to serial number 0T388253 should be inspected for the yellow mark on the end of the crankshaft and flywheel nut or the yellow mark on the starter housing. There are additional color (white and red) marks on the end of the crankshaft and flywheel nut that are applied for other manufacturing aids.

Outboards with yellow marks have been reworked at Mercury Marine and do not require the retorque.

Factory Crankshaft and Nut Yellow Mark.

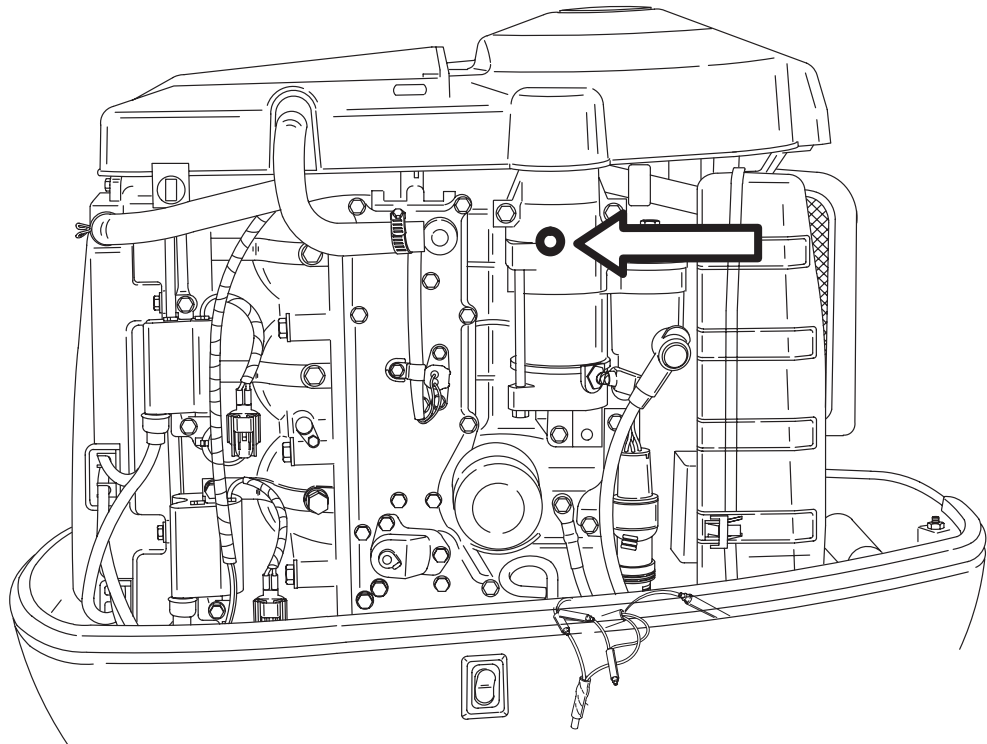
58655

Starter Motor Dot.
