**No. 93-21**

## A. POSSIBLE WATER LEAKAGE PAST TRANSOM MOUNTING STUDS ON ALPHA AND BRAVO TRANSOM ASSEMBLIES.

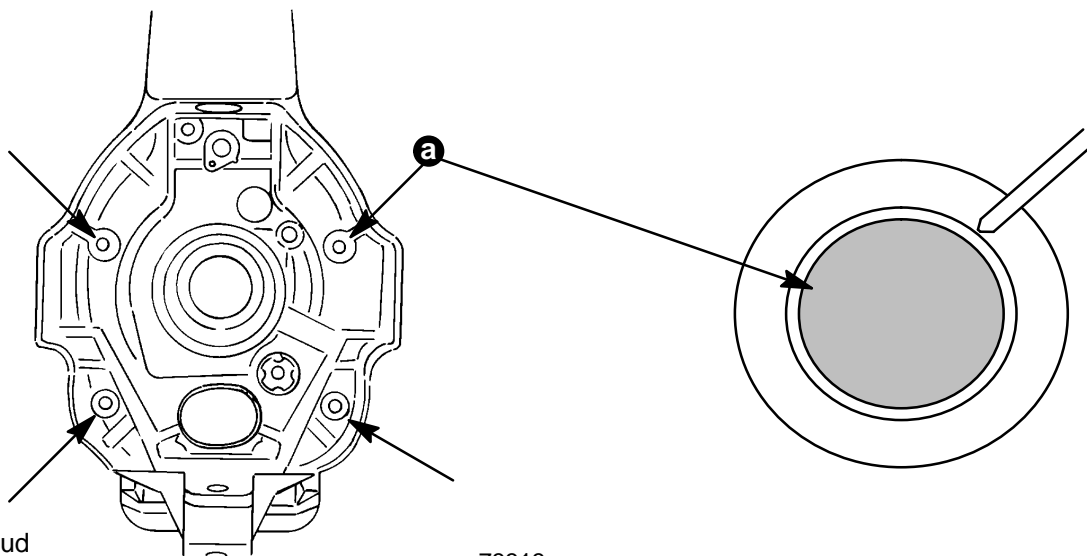
**Figure -1**

Some Alpha and Bravo transom assemblies may have been built with insufficient sealant on the threads of one or more of the transom mounting studs. Studs with insufficient sealant on the threads could allow a small amount of water to weep past the threads and enter the boat over time.

Turn the drive as far to the starboard as possible and apply approximately two drops of sealant to the two exposed studs on the port side of the transom. Apply the sealant to the top of the threaded area so the sealant can wick around the circumference of the stud. (See figure 1.) Turn the drive to port and apply sealant to the two starboard studs.

Let the sealant cure for a minimum of three hours before putting the boat back into the water.
