Bulletin No. 2002-22

## Mechanical Steer Foot Pedal (Tour Edition)

Model	Serial Number or Year
Tour Edition Models	2001, 2002, & 2003 MY 9B000294 – 9B164887

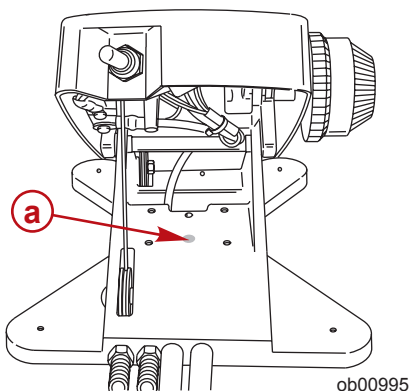
Figure 1

Tour Edition models that are within the affected serial number range should be inspected for a **white** dot as shown. The white dot indicates that the unit has been previously inspected.

**a** - White dot

A **white** paint dot must be applied to the foot pedal after completion of the rework as shown in Figure 1.

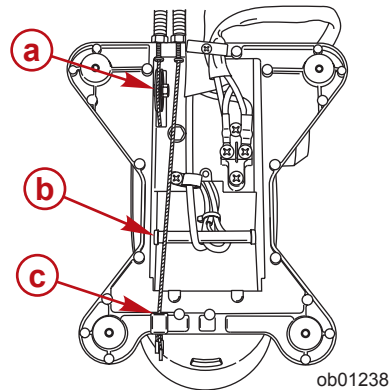
Figure 2

If the foot pedal assembly does not have the identifying mark, check the bottom side of the foot pedal. The e-clip securing the pivot pin should be located on the pulley side of the foot pedal. If the e-clip is located on the opposite side, the foot plate may contact the rear pulley which could cause the steering cable to slip off of it.

- a - Front pulley  
b - E-clip (correct position)  
c - Rear pulley

1. If the e-clip is located on the incorrect side, loosen the tension on the steering cables.
2. Remove the e-clip from the pivot pin and push the pin out.
3. Reinstall the pin ensuring that the e-clip end is on the same side as the steering pulleys.
4. Reinstall the e-clip on the pivot pin. Check to ensure that the steering cables are positioned on the pulleys and tighten the tension on the cables for proper operation. See Figure 2, preceding.
5. After the correction has been completed, apply a white paint dot to the foot pedal assembly.
