service bulletin

No. 90-8

Obstructed Fuel Line Connector – Mariner/Mercury 8-200 Models

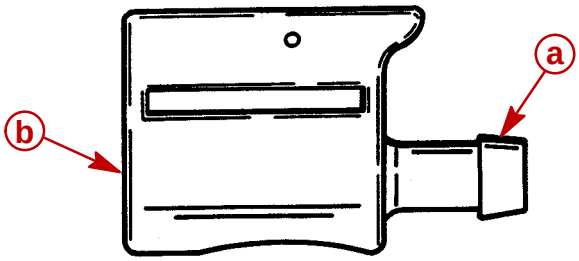
Figure 1. Fuel Line Connector P/N 22-13563A3

Fuel line connector P/N 22-13563A3 may have excess plastic in the fuel passageway inside the housing. Excess plastic may prevent full coupling of the fuel line to the outboard furl connector and/or restrict fuel flow to the engine. Outboards and service stock listed require inspection of fuel line connector.

a - Fuel Line End
b - Brass Piece in End

Inspect for excess plastic in passageway by looking into connector from fuel line barbed end. Brass piece on opposite end of connector should be fully visible. If brass piece is not visible, the connector is defective and must be replaced.

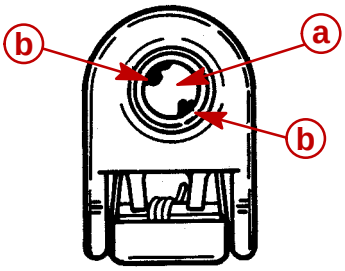
Figure 3. Obstructed Fuel Connector

a - Brass Piece Partially Visible
b - Excess Plastic in Passageway
