service bulletin

No. 91-32

Sta-Strap Interference with Throttle Cable Sleeve – 1992 75 thru 115

S/N 0D096367 thru 0D107109

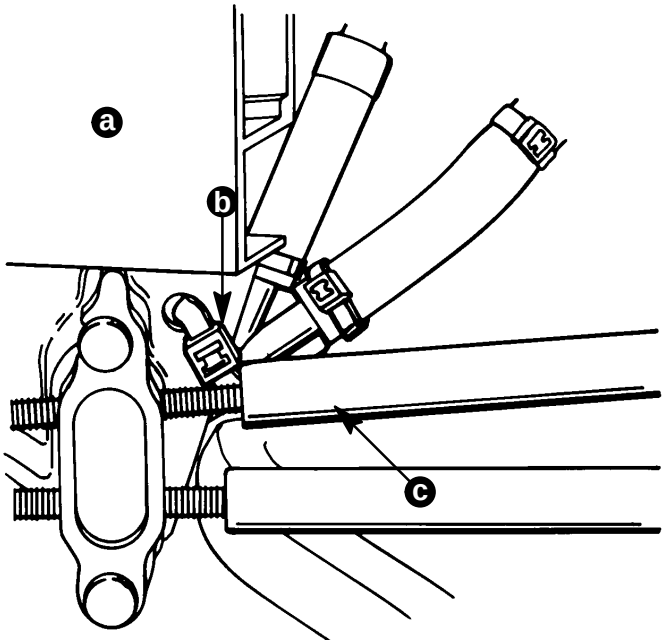
51544

Inspect the sta-strap that holds the fuel line to the carburetor air intake. If the sta-strap locking tab is pointing straight out, it may contact the throttle cable sleeve at full throttle. This contact may prevent full throttle operation.

Sta-Strap Locking Tab Contacting Throttle Cable Sleeve

Turn the sta-strap until the locking tab is down and can not contact the throttle cable sleeve.

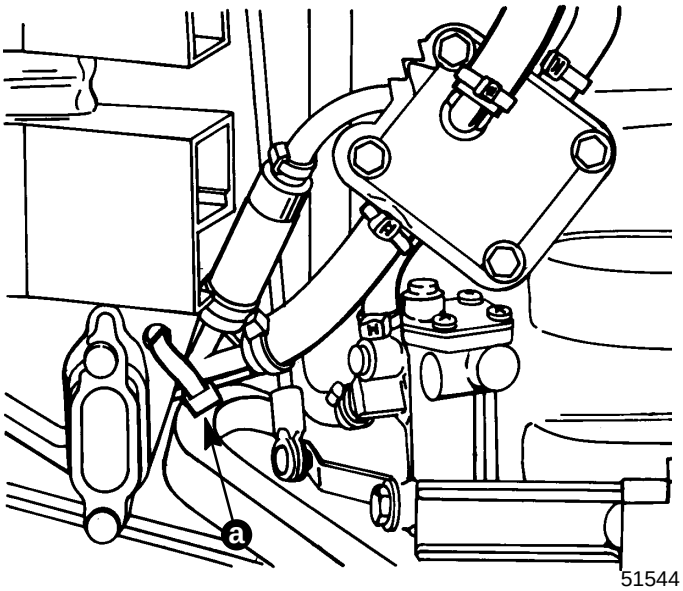
51544

Sta-Strap Locking Tab in Correct Position
