mercruiser
STERN DRIVES & INBOARDS

service bulletin

No. 89-31

Alpha One - Bravo One and Bravo Two Trim Sender Indexing Marks Misaligned

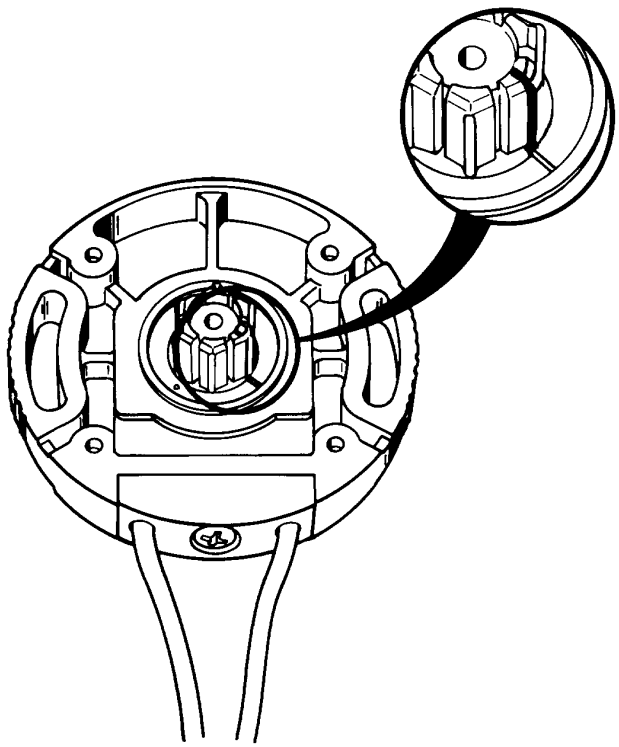
50842

It has been brought to our attention that the indexing marks on the Alpha One and Bravo One and Bravo Two trim position sender may not be aligned properly. Please remove and align indexing marks as shown in the following diagram. When indexing marks are misaligned the trim gauge needle will jump to the top end of the gauge scale when trimming. Units affected are from serial number 0C833540 thru 0C888889.

IMPORTANT: Sender adjustment must be done with stern drive at full down "IN" position. DO NOT adjust sender with stern drive at maximum trim position because sender may be damaged or give incorrect gauge readings.
