service bulletin

No. 91-9

A. OIL LEAKING FROM WATER PICKUP HOLES IN GEAR HOUSING ON ALPHA ONE GENERATION II DRIVE

MCM 3.0L/3.0LX/4.3L/4.3LX/5.0L/5.0LX/5.7L Alpha/350 Magnum

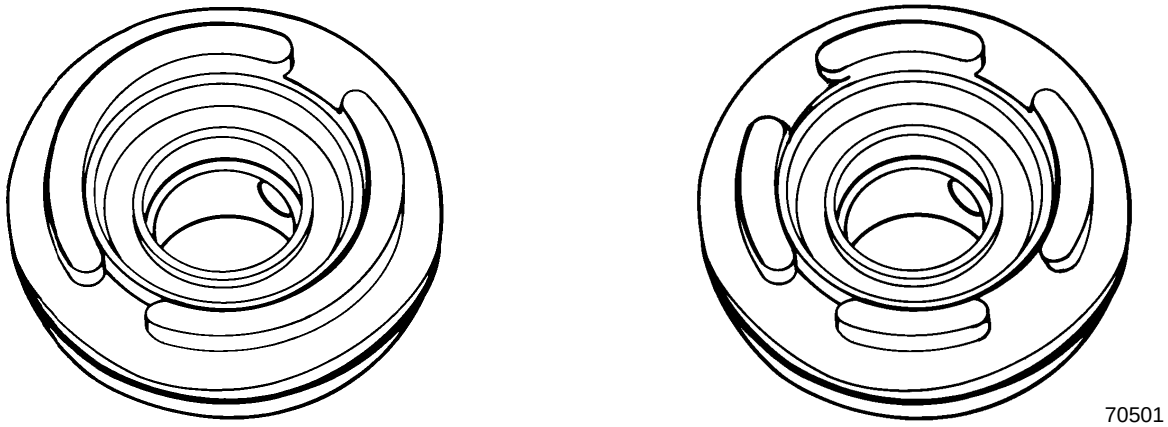
70501

The oil seal carrier is being changed from the brown color (aluminum) material back to a black glass filled nylon material. This new seal carrier will supercede the aluminum version. The new seal carrier can be identified by looking at the base where the old plastic carrier had only two support feet the new one will have four support feet.

A. Old Style **B. New Style**

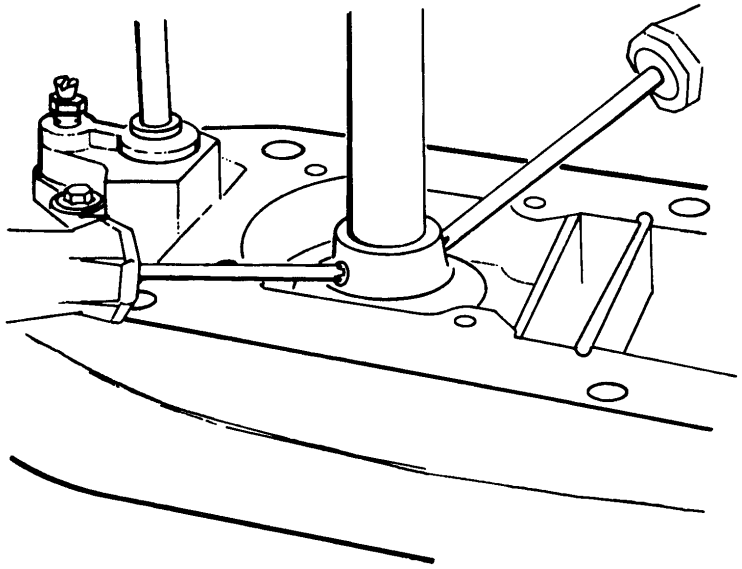
70489

If oil is detected leaking from the water pickup holes in the gear housing, the oil seal carrier under the water pump face plate may be cracked. This would cause oil to leak from the water pickup holes in the gear housing and could lead to gear failure.

Remove cracked carrier from gear housing using a couple of screw drivers to lift it up and out of the housing bore.
