service bulletin

91-24

A. ALPHA ONE/MCI 1990 AND PRIOR, LOWER DRIVE SHAFT

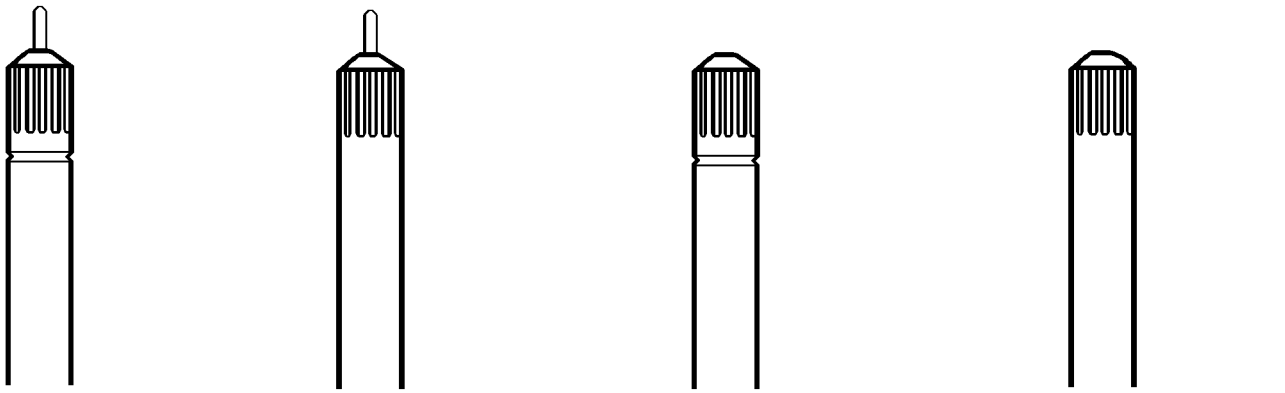
71185

The service drive shaft for the lower unit will no longer have an O-ring groove at the top of the shaft under the splines on all Alpha One 1990 and prior also MCI back through 1976. The drawings below show the old and new configurations for the drive shafts.

OLD STYLE (A)	NEW STYLE (B)	OLD STYLE (C)	NEW STYLE (D)
MCI with the O-ring groove	MCI without the O-ring groove	Alpha One with the O-ring groove	Alpha One without the O-ring groove

When installing the complete lower assembly to the upper housing adequately grease the oil seals and the area between the seals in the drive shaft housing, and the splines on the end of the drive shaft with Quicksilver 2-4-C Marine Lubricant (92-90018A).
