mercruiser
STERN DRIVES & INBOARDS

service bulletin

No. 92-20

A. ALPHA ONE/ALPHA ONE GENERATION II R/MR GEAR SETS

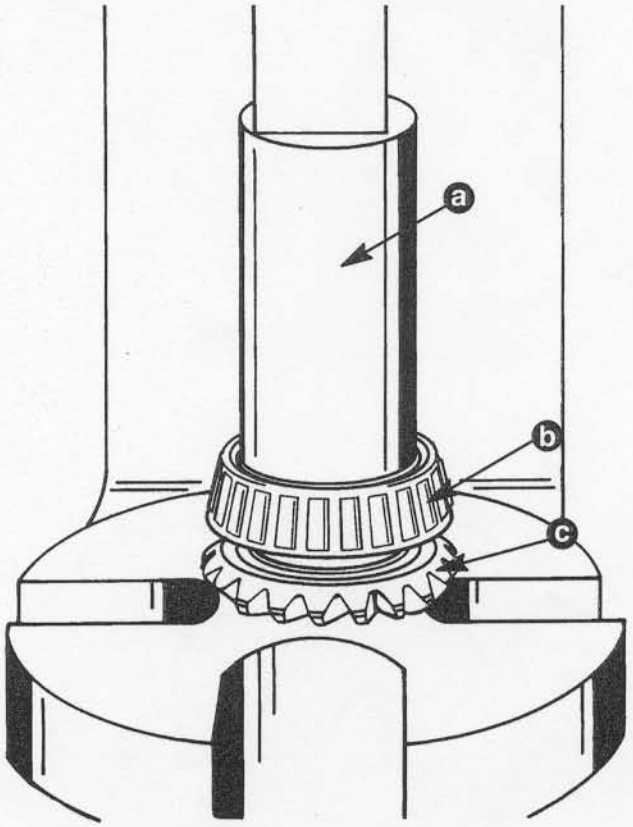
On the above listed gear sets we have been getting feed back that the bearings do not fit on the gears or too tight of a fit to the gear, an interference type fit.

Follow the instructions in this service bulletin or the instructions that come with the gears.

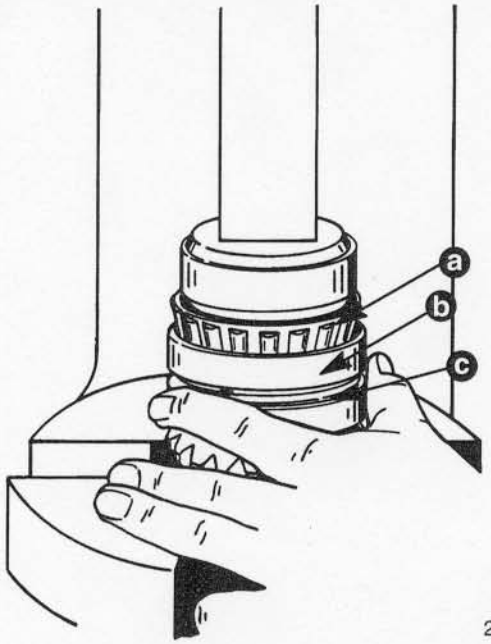
22393

a - Suitable Mandrel
b - Bearing Cone
c - Drive Gear

1. Press the first bearing cone onto drive gear until it is firmly seated.

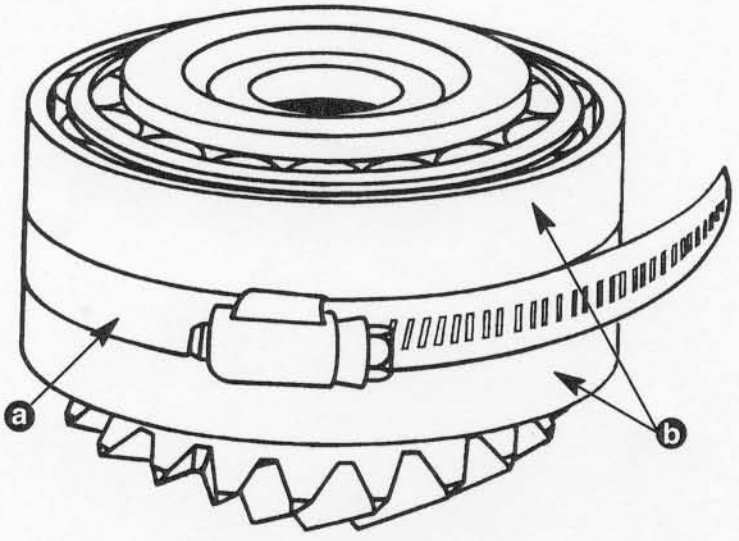
22393

Use care in pressing the second bearing cone onto gear to avoid placing a premature preload on the bearings. Excessive force could also damage the bearings. Press the second bearing cone on only until it just starts to make contact with the bearing cup.

a - Bearing Cone
b - Bearing Cup
c - Spacer

3. Press the second bearing cone onto gear until the rollers just contact the cup.

NOTE: If a slight over-press condition occurs (spacer does not move freely) - support second bearing cup with universal puller plate and lightly tap end of gear with a soft hammer. Failure to do this will result in a high initial preload when you check it in the following steps.

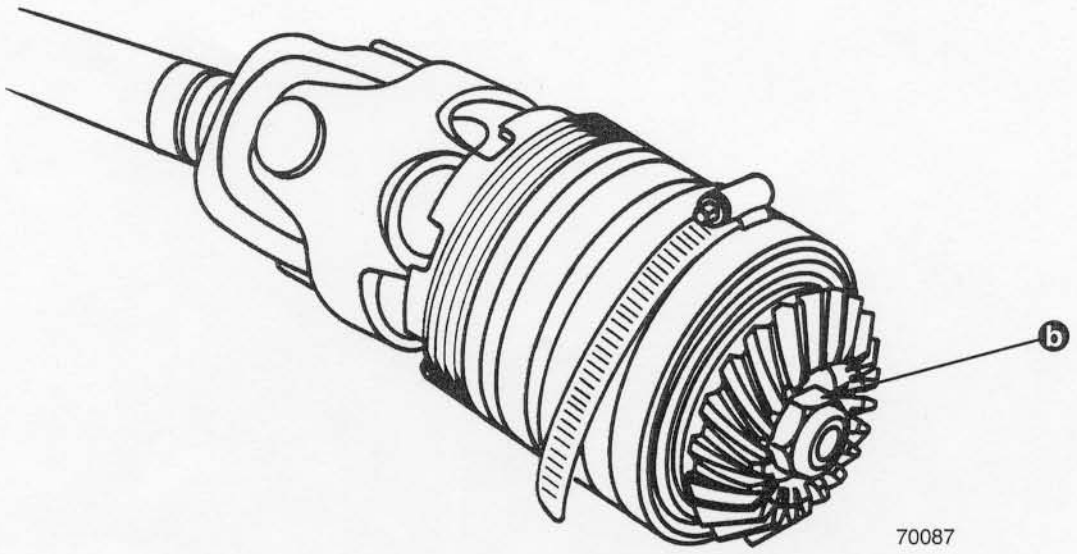
23267

a - Washer

6. Install drive gear and bearings onto u-joint shaft. Secure with washer and locknut. Tighten until locknut just makes contact with washer.

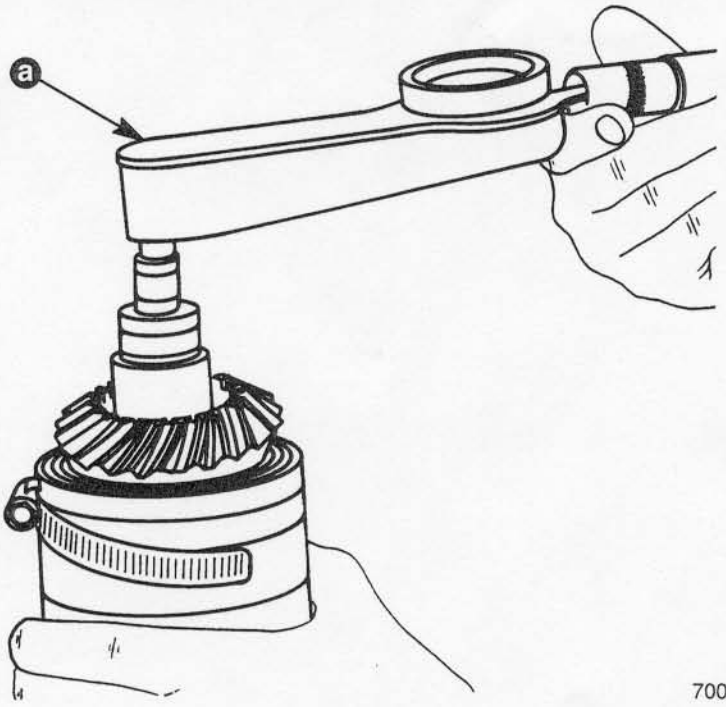
70086

a - Torque Wrench (lb. in.)

7. Set preload by tightening nut 1/16 of a turn at a time. Check for proper preload by turning gear using a torque wrench, until a 6-10 lb. in. (0.7 - 1.1 N·m) torque is obtained. If nut is accidentally overtightened (causing excessive preload), it will be necessary to loosen the locknut, and lightly strike the gear and bearing assembly to loosen the preload. You should then repeat this entire procedure.
