service bulletin

No. 95-10

MerCruiser MCM D7.3L/270 Diesel Stern Drive Replacement

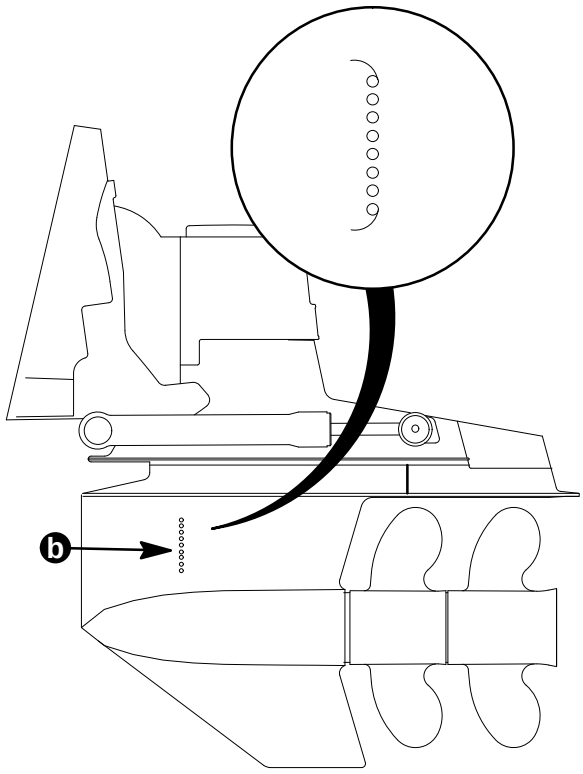
74717

An overheat situation could develop if the D7.3L/270 diesel model engines are mated with a 1996 Bravo Three.

a - Water Intake - 9 holes 94-95 M.Y.
b - Water Intake - 8 holes 1996 M.Y.

If replacing a 1994 or 1995 Bravo Three with a 1996 Bravo Three (all gear ratios) a thru hull water pick up kit (P/N 88845A2) is required to supply adequate water flow to the engine. The 1996 Bravo Three has an 8 hole water pick up, whereas the 1994 and 1995 Bravo Three had a 9 hole water pick up.
