# service bulletin

**No. 96-2**

## Water In Fuel Module (WIF) Warning Light

MCM/MIE D7.3L/270 Diesel Engines

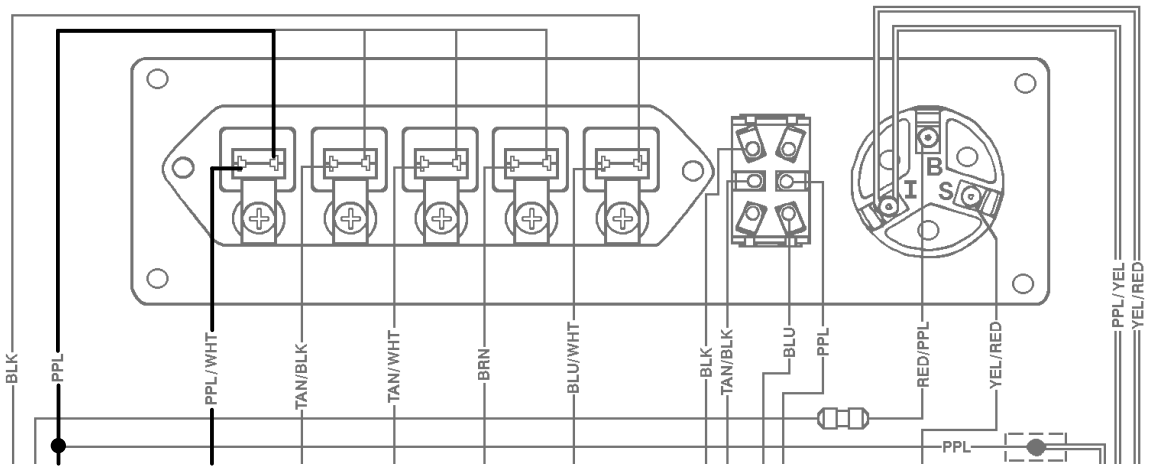
72432

The warning light on the Engine System Monitor Panel may not operate correctly.

### Current Wiring Set Up

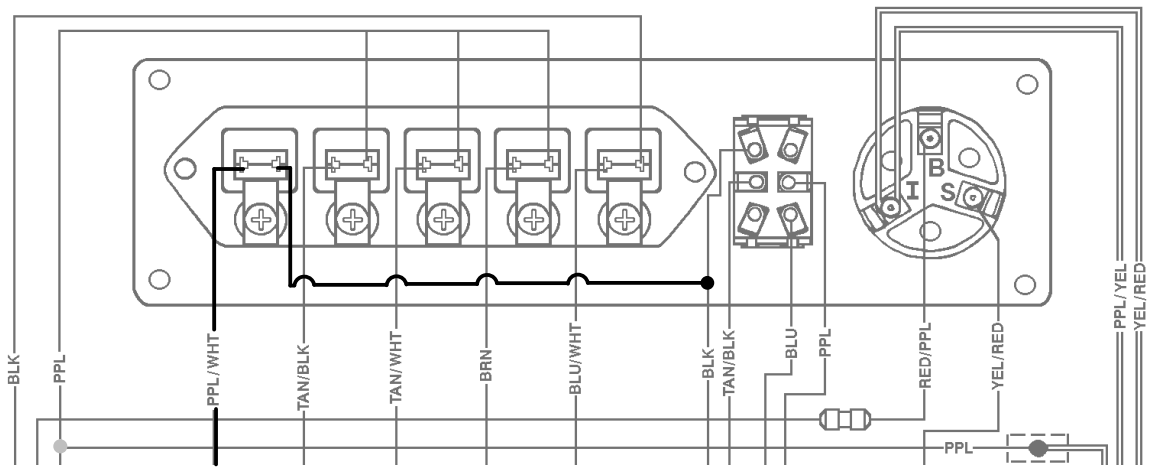
72432

### Correct Wiring Set Up

Change wire on WIF light on Engine System Monitor Panel as shown.
