service bulletin

No. 96-11

Hurth Transmissions

HSW 630-A Marine Transmissions

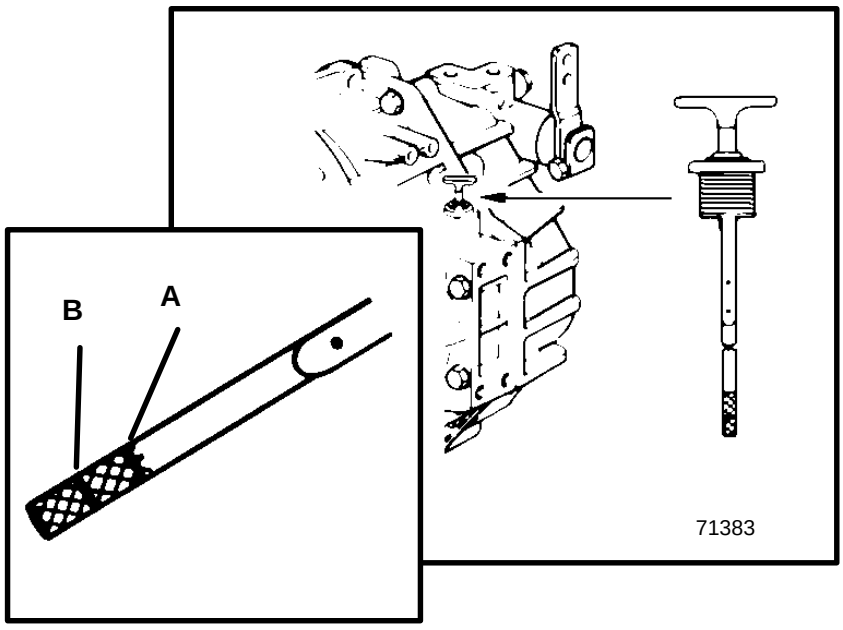
Fluid levels higher than the full mark when the engine and transmission are installed in the boat.

Fluid levels should be checked with the boat at rest in water. If transmission fluid appears to be higher than the full mark on the dipstick before running engine package, remove fluid from transmission to read between the A and B mark on the dipstick (shown below). Run engine, shifting transmission in and out of gear to bring up the temperature of transmission fluid. After running engine package to increase the temperature of the transmission fluid (to compensate for expansion), shut down engine and immediately check the level of the transmission fluid. If fluid level is above the full mark (A), remove excess fluid to read between the A and B mark on the dipstick.
