mercruiser STERNDRIVES & INBOARDS

service bulletin

No. 98-2

Operating a Bravo One Performance Drive with Low Water Inlets in shallow water

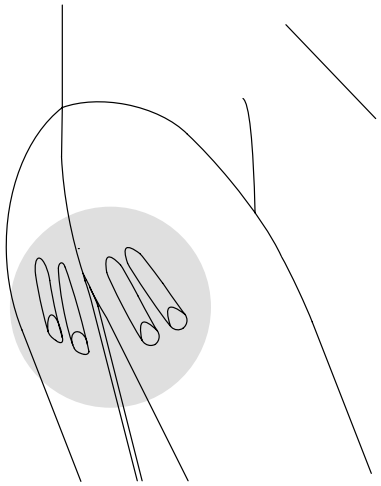
75827

Serious engine damage could occur by failing to follow these instructions. Sand, silt or mud could be sucked into the water inlets restricting or shutting off the water supply to the engine.

Low Water Inlets Gear case

Extreme care should be exercised when operating a boat equipped with a performance Low Water Inlet Drive while maneuvering in shallow water. Also, avoid beaching the boat with the engines running.

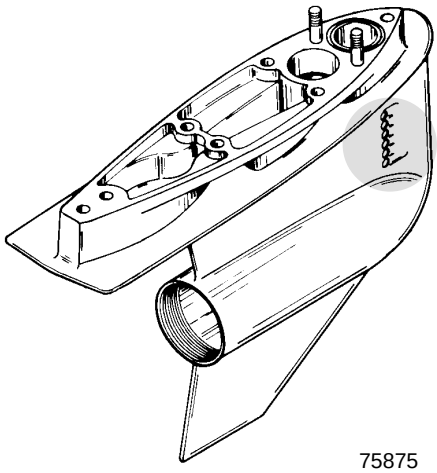
75875

Standard Side Water Inlets Gear case
