MERCURY MerCruiser

Service Bulletin

☐ Warranty Information ☐ Service Information Bulletin No. 2003-10r1
☑ Parts Information

Hairpin Cotter 18-859746 is NLA

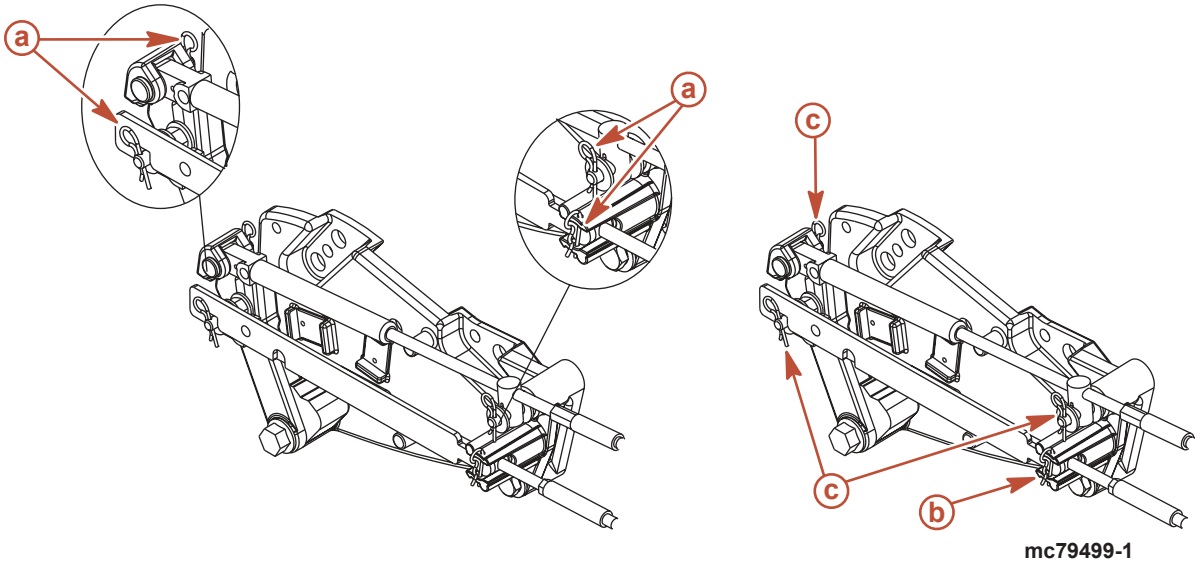
Qty. 1 of 18-32857-1 cotter pin for transom shift cable retention.

Qty. 3 of 18-21071-1 cotter pins for shift lever clevis pin and studs.

Hairpin cotter 18-859746 that retains the shift cables on the shift plate assembly on all MCM engines must be replaced with (1) of 18-32857-1 cotter pin at the shift cable anchor on the Alpha switch actuating arm and Bravo shift cable retainer plus (3) of 18-21071-1 cotter pins for the two studs and the clevis pin on the shift lever of both the Alpha and Bravo shift plate assemblies.

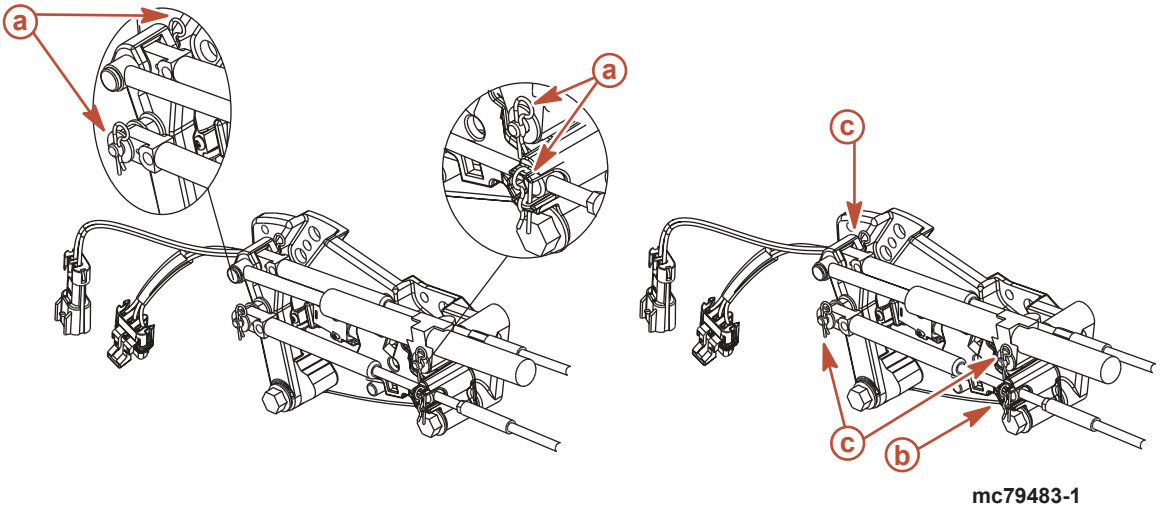
Bravo shift plate

a - Hairpin cotters
b - Location to install 18-32857-1 cotter pin
c - Locations to install 18-21071-1 cotter pins
