Service Bulletin

Bulletin No. 2005-66
CMD 2005-06

2.8L Sea Water Drain Plug Location

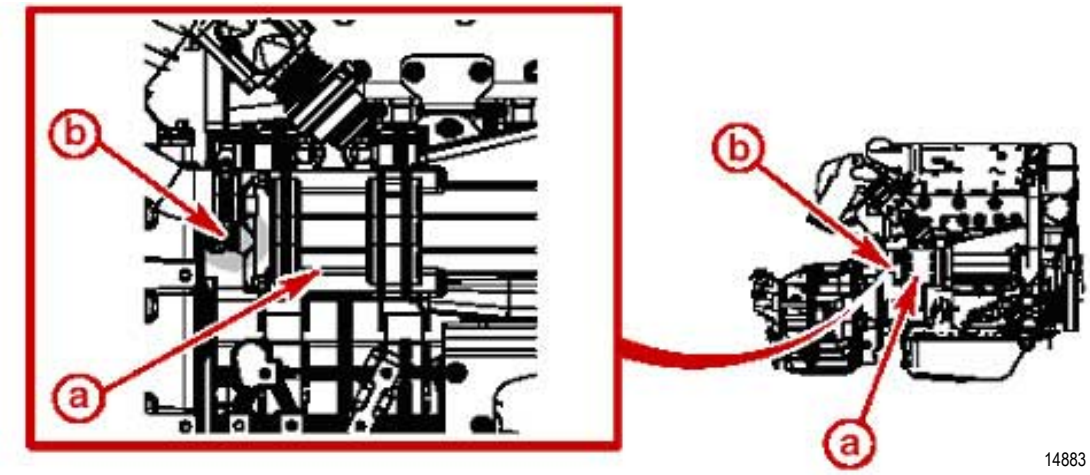
Figure 1

The Owners manual PN# 90-865861041 for the inboard version of the above engines has incorrect data on page 81. The call out location for the plug to drain the sea water from the heat exchanger incorrectly points to the freshwater coolant drain plug. Removing this plug will result in the loss of engine coolant.

a - Transmission fluid cooler b - Drain plug, or fitting if equipped

The correct location for draining the sea water from the heat exchanger and transmission cooler is located on the rear of the transmission cooler (refer to figure 1). Owners manual PN# 90-865861041 has been updated with the correct information and is re-issued under part number 90-865861050.
