MotorGuide MARINE

service bulletin

Bulletin No. 2003-04

Incorrect Door Knob Bushing On 21/24 Gator Mounts

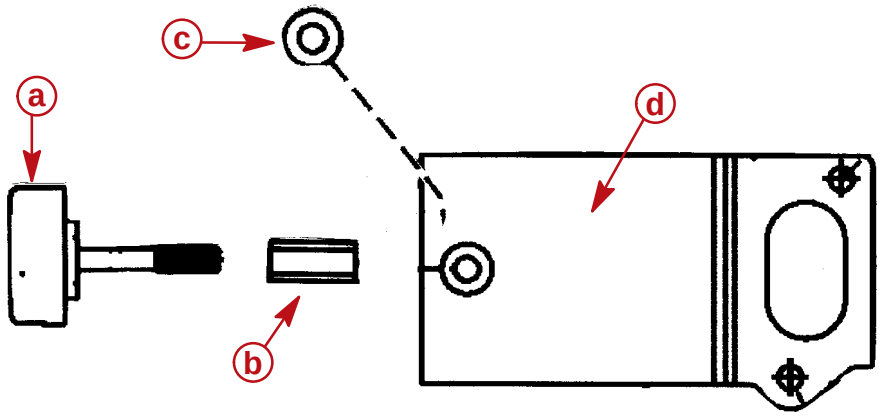
Manufacturing may have installed a plastic door knob bushing on the above listed mounts rather than the normal metal bushing.

a - Knob
b - Bushing
c - Washer
d - Door

If the plastic door knob bushing is found in the above listed mounts, replace the bushing with a metal door knob bushing.

Qty.	One (1)	MRK02105 door knob bushing
Qty.	One (1)	MRK17106 washer
