ADVISORY
 BULLETIN

No. 2001-06

Official Notification Federal Boat Safety Act Flywheel Nut Retorque - 115 EFI Four Stroke

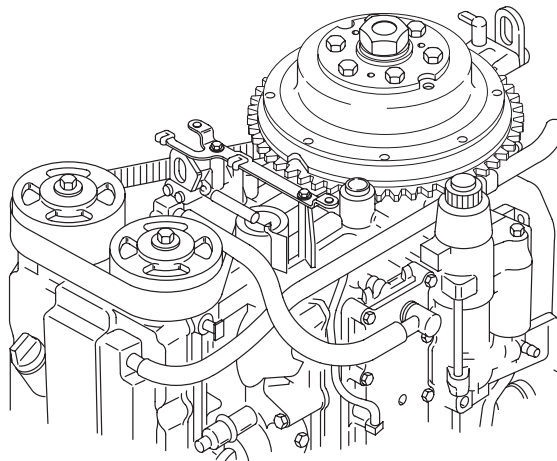
57601

Mercury Marine Inventory – Inventory has been reworked and marked with a yellow line across the end of the crankshaft and flywheel nut surface. A yellow dot is also placed on the starter motor housing.
