merCruiser
STERN DRIVES & INBOARDS

service bulletin

No. 89-27

4.3LX and 5.7L Choke Rod Linkage

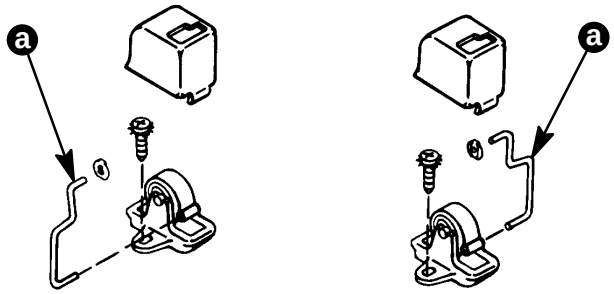
The list of serial numbers following are engines having a incorrect installation of the choke rod linkage. The linkage is installed in reverse of normal installation. Figure 1

The engine may experience a hard start or a rich running condition.

When servicing these engines inspect the choke linkage for proper installation.

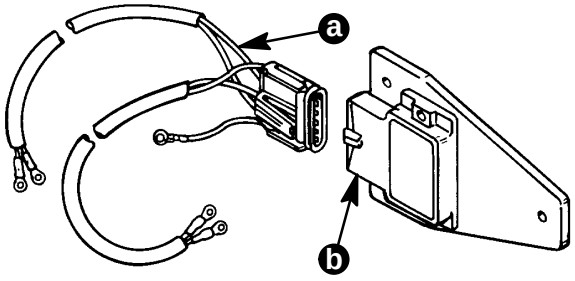
Figure 2

This problem only affects the type of HEI Amplifier and its wiring harness as shown below in Figure 2.

If you experience an engine back-fire or mis-fire above 3000 RPM (especially when activating an electrical accessory such as the power trim or the boats trim tabs), check the wire going to the plug-in connector terminal(s). On some units the WHT/RED and PUR wire is cross wired at the connector. Refer to Figure 3 for correct wiring.

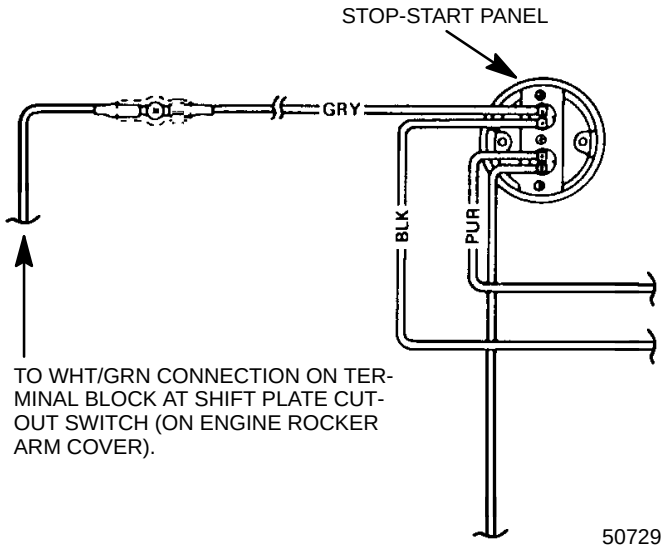
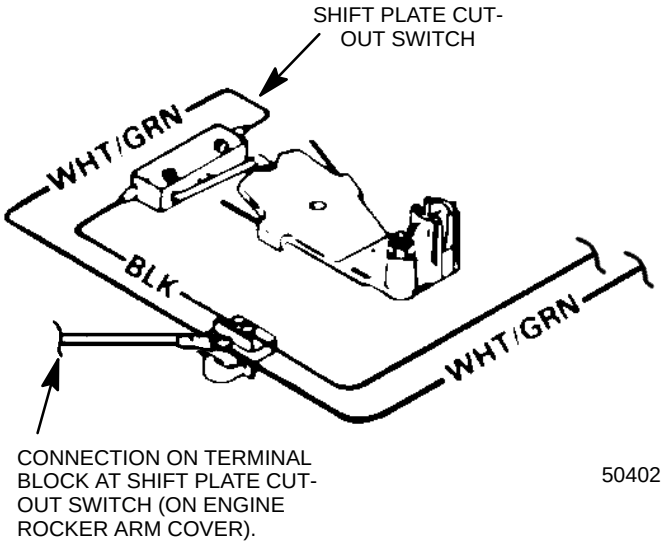
Because of the different wiring configurations between the D.D.I.S. Ignition and the Conventional ignition Systems the above mention kit must be wired as shown (Figure 4 and 5) when being used on the D.D.I.S. System.

Connecting the kit using the Conventional Ignition procedure will not allow the D.D.I.S. Ignition engine to stop.

A separate 16 gauge wire (not supplied) must be attached outside the wire harness from the stop button back to the shift plate cut out switch on the engine.
