mercruiser STERN DRIVES & INBOARDS

parts bulletin

No. 95-2

V6 & V8 Replacement Cylinder Heads

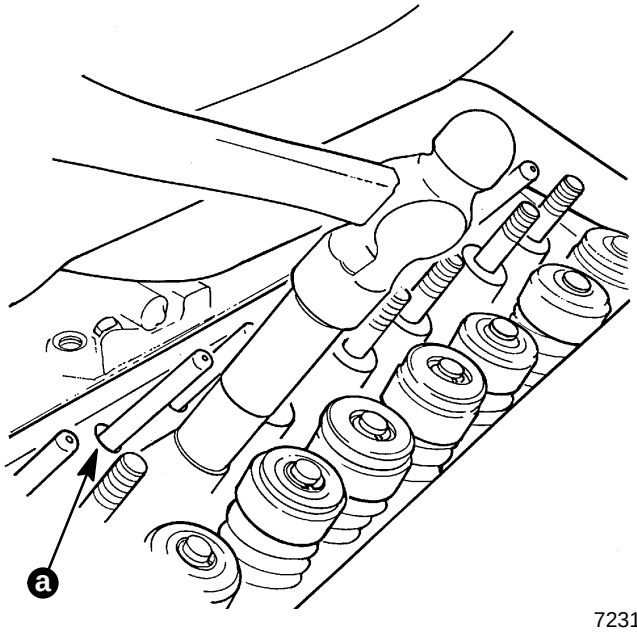
Before ordering a replacement cylinder head for any of these engines, look at the hole in the cylinder head that the push rods come through. Also look at the type of rocker arms that came off. If the rocker arms are not the “Self Aligning” type rocker arms, all new rocker arms must be ordered also. All replacement heads have a hole for the push rod. If “Self Aligning” type of rocker arms are not used with these new heads, the rocker arm will not stay on the push rod.

a - Push Rod Hole: Slot=Keeps Push Rod Aligned.
Drilled Hole=Must Use “Self Aligning” Rocker Arm.
b - “Non Self Aligning” Rocker Arm.
c - “Self Aligning” Rocker Arm.
